TECHNICAL BULLETIN		
 	July 2002 TB 1996

Optimum Placement Of Camshaft Bearing
Oil Feed Hole Location

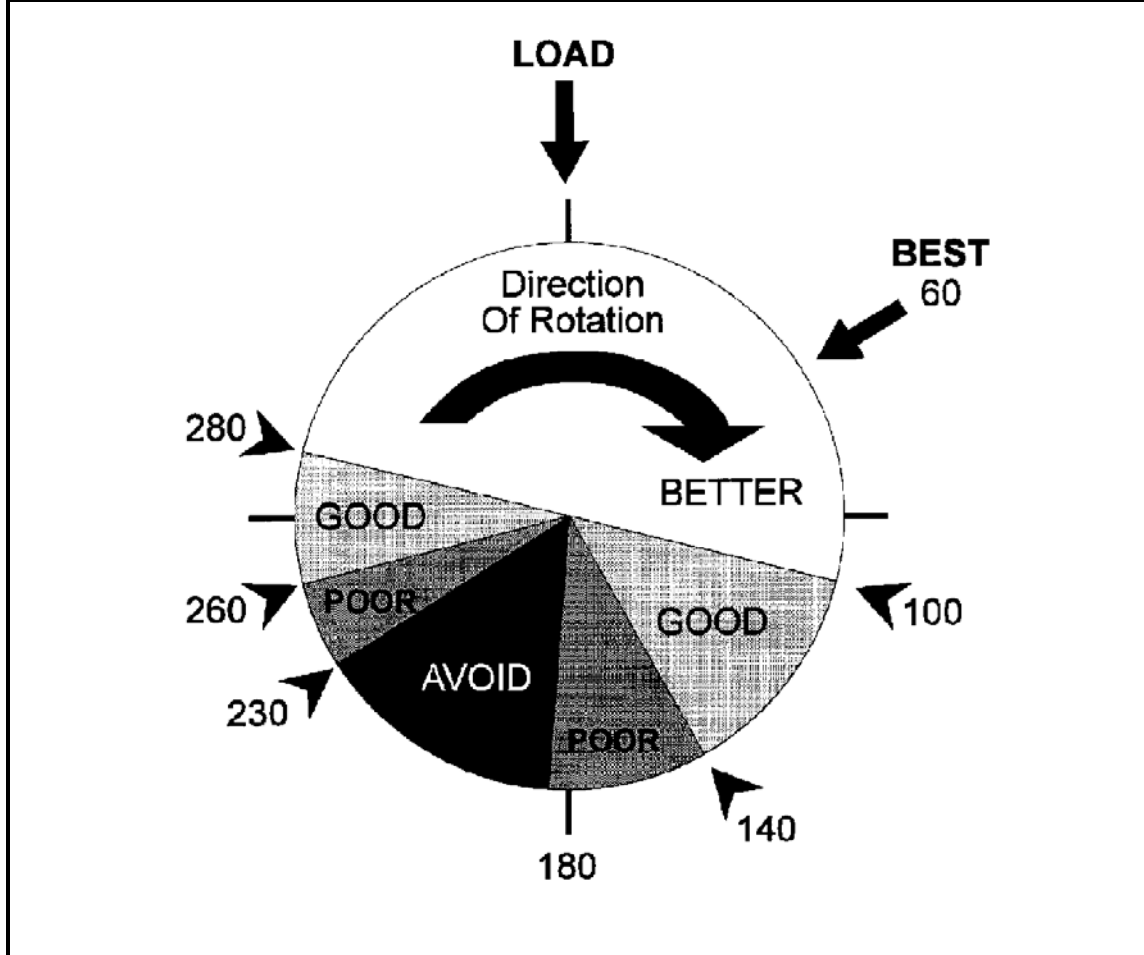
Bulletin Diagram: FIGURE 1, OIL HOLE LOCATIONS - CYLINDER BLOCK

Maximum camshaft support will be realized by installing the cam bearing oil feed hole to the optimum clock location. Blocks and heads using a 360° oil groove located behind the bearing oil feed, allow one to move the clock position of the cam bearing oil feed hole. This way you can adjust the clock position during cam bearing installation to make sure that the optimum location for the best hydrodynamic wedge is selected. Locating and installing the cam bearing to take advantage of this hydrodynamic wedge will supply the maximum support for the camshaft during engine operation. The direction of camshaft rotation and the engine oil entry point into the bearing control the placement of the hydrodynamic wedge.

The illustration in Figure 1 below shows the optimum engine oil feed hole location for a camshaft that is turning clockwise as viewed from the front of the engine.

Note: If the camshaft being used is driven with a gear-to-gear arrangement, or is a reverse rotation engine with a chain drive, the cam bearing oil feed hole will require

repositioning to the opposite lower side. This is due to the fact that the camshaft is turning in the opposite direction as noted above.
